U.S. Department  
of Transportation  
**Federal Aviation  
Administration**

## **ADVISORY CIRCULAR**

# **AVIATION MAINTENANCE ALERTS**

**ALERT  
NUMBER  
306**

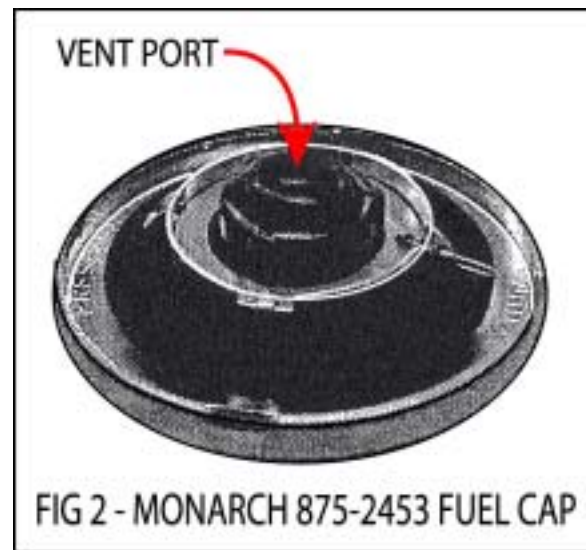
The pass/fail criterion is defined as follows: The cap passes if it allows air into the bulb after applying a small vacuum (0.02 – 0.07 psi) and it fails if it opens immediately or is sealed and does not allow air to pass thru and thus vent the tank. These vacuum pressures correspond to the range of height values,  $h$ , shown in Table 1. Caps that open before the minimum pressure is reached or fail to open before the maximum pressure is reached fail this test. Caps that fail this test are to be replaced before the aircraft is returned to service. This inspection should be performed every 100-hours of flight operation or every twelve months, whichever occurs first, and entered in the aircraft log book.
